Re: The John Calder House
7675 Thickson Road, Whitby
Heritage Designation, Part IV
The Ontario Heritage Act

DESIGNATION AND ARCHITECTURAL REPORT FOR THE JOHN CALDER HOUSE

ARCHITECTURAL REPORT

7675 Thickson Road
North West Quarter of Lot 20, Concession 7
Township of Whitby
Built 1856

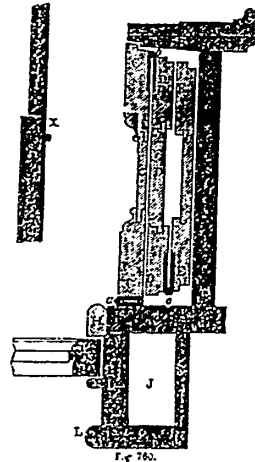
Fig. 760.

2147. Fig. 760 is a plan of the shutters, architrave, sash-frame, and part of the sash of common shutters. The cavity which forms the boxing into which the sashes fold is formed by the ground B (upon which the architrave A is nailed), the back lining F of the boxing, and the inside lining G of the sash-frame, whereof H is the inside lead. L is the outside lining of the sash-frame, M the back lining of it, and K the parting lead, so called from parting the upper and

lower sash. The vacant space J, between the sash piece I and M, is a cavity which contains the weights for balancing the sashes; N shows the plan of one of them. The shutters, when stretched out in their different folds, are supposed to cover one half of the window, another series being supposed to be placed on the other side of it. The front shutter CCC is hung by hinges at a to the inside lining G of the sash-frame. The inner shutters DDD and EEE are called the back flaps, the former of which is hinged on to the front shutter at b, and the latter is hinged on to DDD at c. It will be immediately seen that these three will thus altogether turn upon the hinges at a, and cover, in one straight line, from both sides, the whole of the light of the window. When the boxes are scanty, the hinge, called a back flap hinge, may be placed as shown in X attached to the figure.

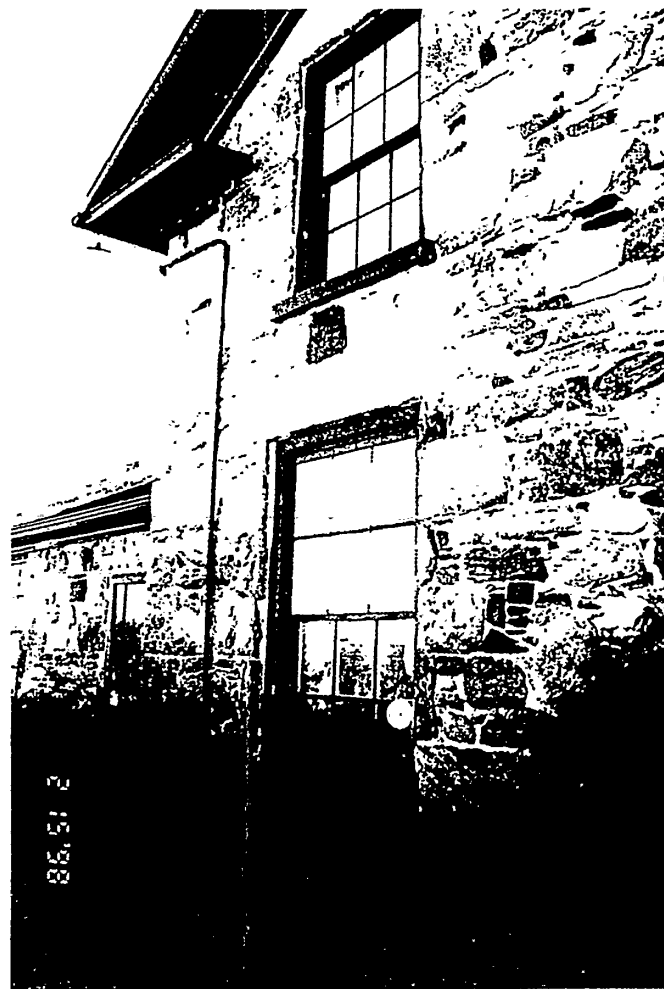
8. view of the north east corner of the main house - note lack of bonding of the stonework with the rear wing
9. milk shed and outbuilding with board siding

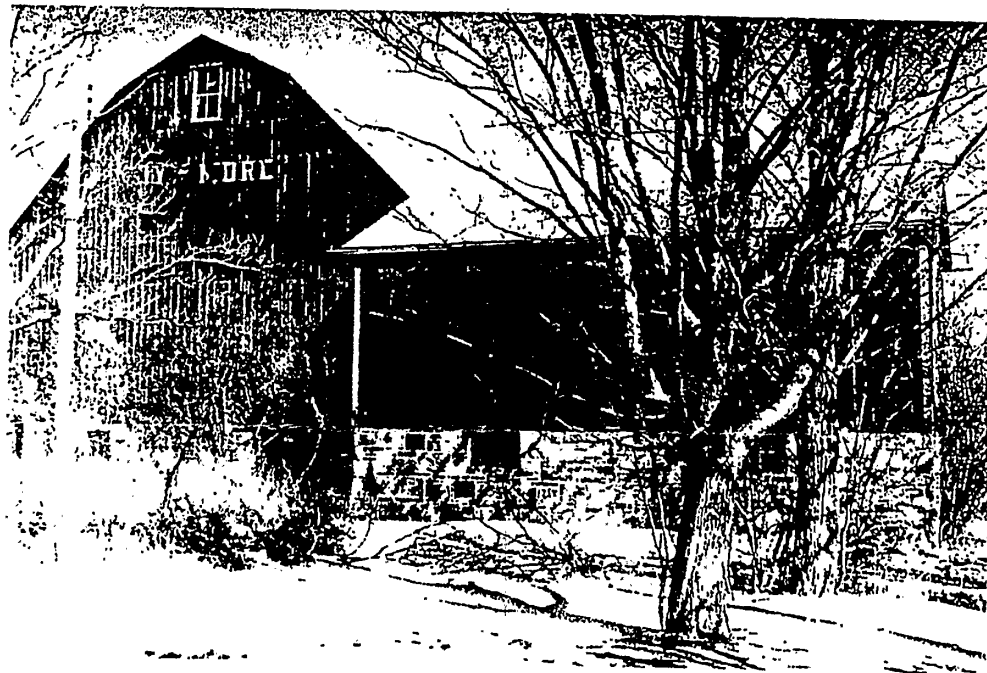
10. interior of milk shed with boarded interior
11. view of barn (neighbouring property) - part of the original property
12. basement of barn with date stone reading 1895

At the back of the property, on the other side of the property line, is the Calder's barn. It has a very finely executed coursed ashlar basement, with a date stone indicating that it was built in 1895. The high quality of the ashlar stonework on the barn, which is similar to the work on the house, suggests that the long term occupancy of the property by the one family⁴. Stonework of this quality is usually attributed to Scottish stonemasons, which is appropriate for the Calder family, who were Scottish immigrants.

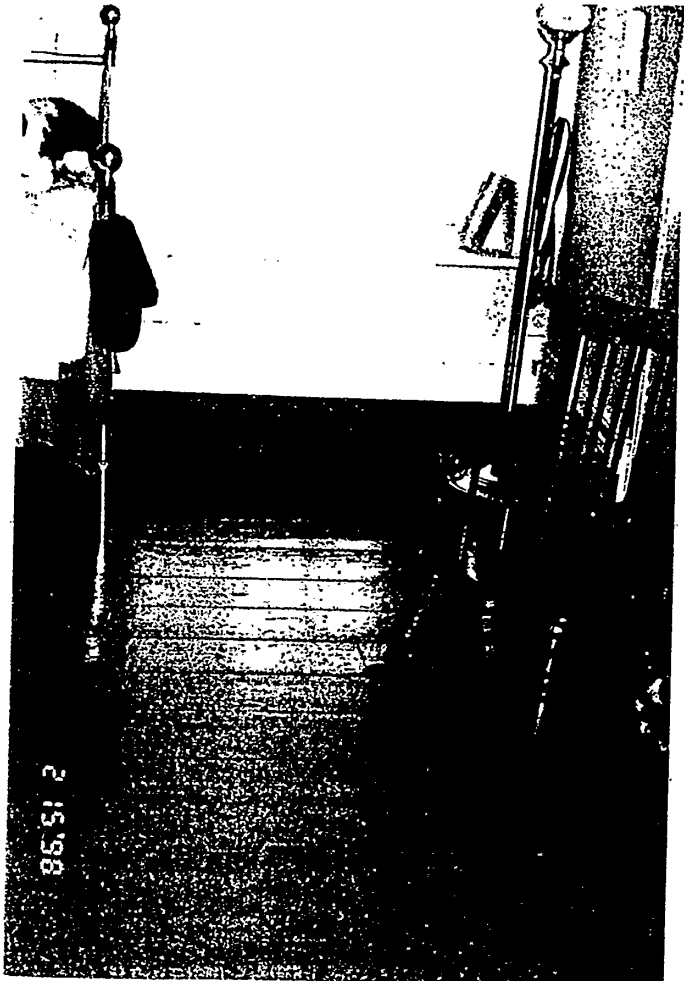
16. painted wood floors on the second floor . .
17. paneling in the embrasure of the windows of ground floor
18. hand-split lath in the stairwell to basement

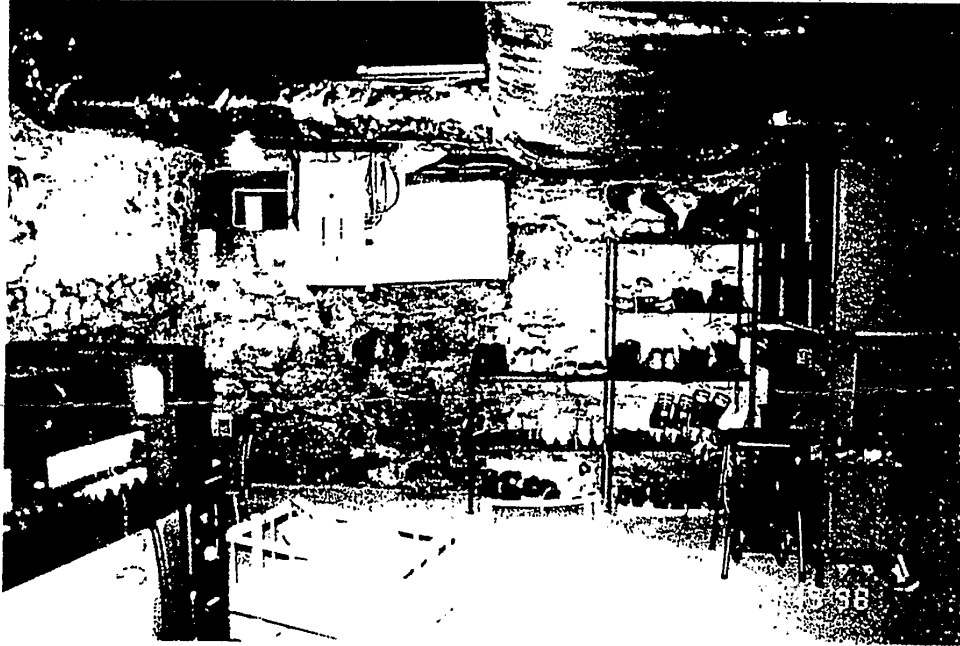
13. interior of north side of basement - note window, which is concealed on the exterior, is blocked by insulation on the interior
14. remainder of interior wall which separated the basement - note the wall consists of a wood post, with brick and stone blocking

¹² The basement windows on the north side have been covered over on the exterior. The reason for the change in grade is unclear and it is not known when this occurred.

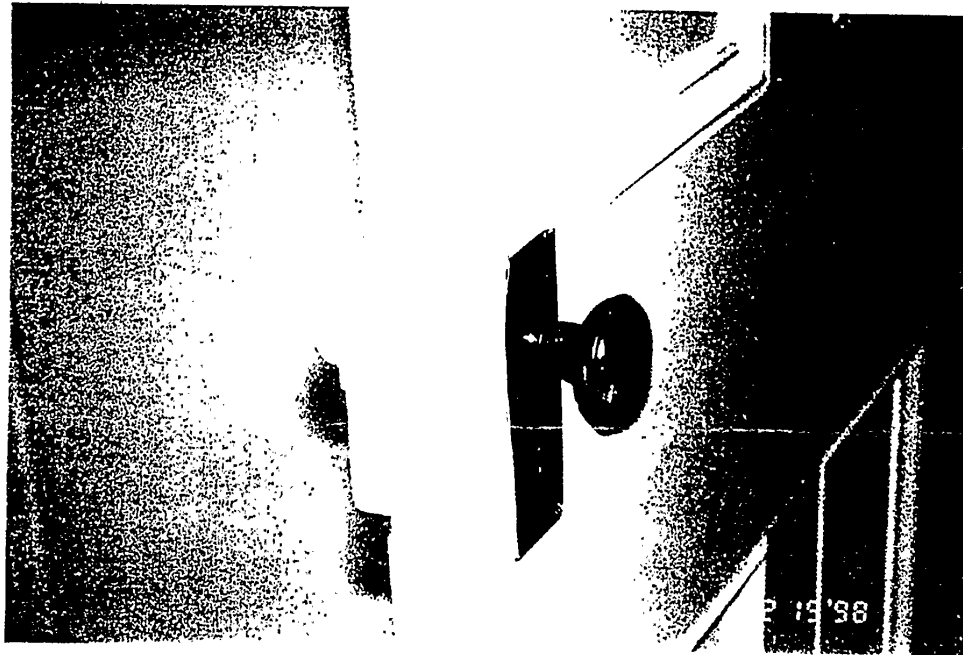
19. typical hardware for the doors on second floor
20. view of reused railing from the servants stair now used at the top of the main stair
21. view of the stripped newel and railing of the main stair

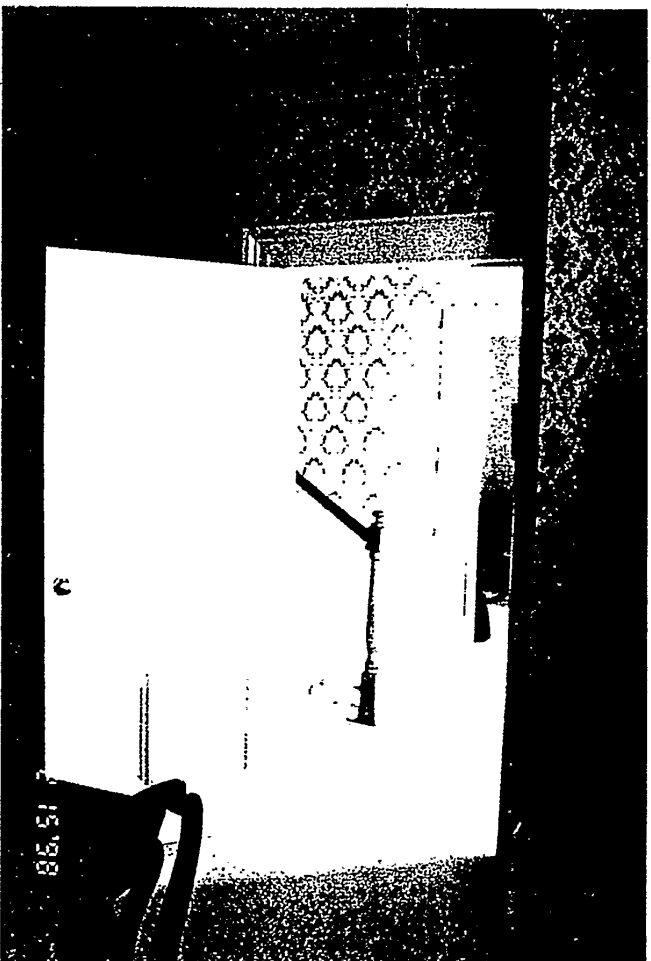
22. typical interior view showing the doors and door surrounds leading into the hallway
