Window Rehabilitation and Restoration Guidelines for Heritage Conservation and to Reduce Greenhouse Gas Emissions

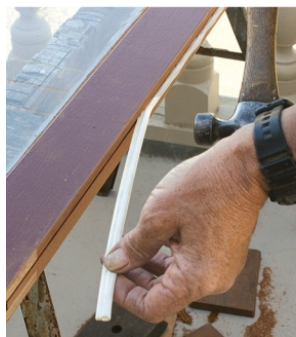
- Weatherstripping – Install metal weatherstripping at operable joints to help minimize air infiltration (interlocking metal strip, bronze or copper V-shaped strip or felt). Strippable caulking can also be used on the inside of the windows to help prevent air leakage. Caulking should be applied during the colder months and removed in the warmer weather to allow the windows to remain operable.

There are many options for increasing the thermal performance of an historic wood window. Air infiltration can be minimized by adjusting the interior and exterior stops and parting strip so that they fit snugly against the sash without binding. Counter-weights can be adjusted so that the bottom sash is drawn downward and the upper sash upwards for proper sealing. Weatherstripping the windows along with the addition of storm windows or interior glazing can also help achieve a higher thermal efficiency. The addition of storm windows when done properly can minimize damage to the historic fabric and preserve the visual qualities of historic windows. Prior to proceeding with thermal upgrades the window should be in sound condition with all necessary repairs complete.

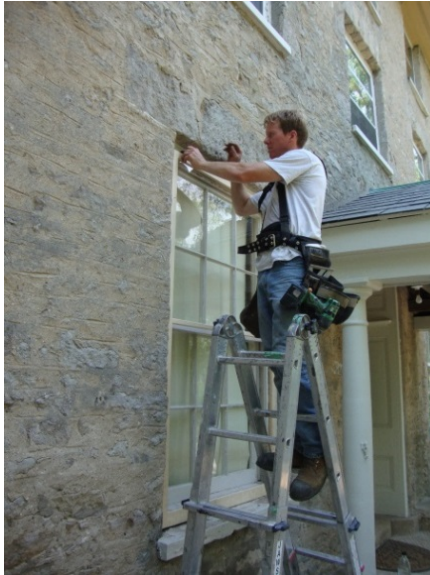
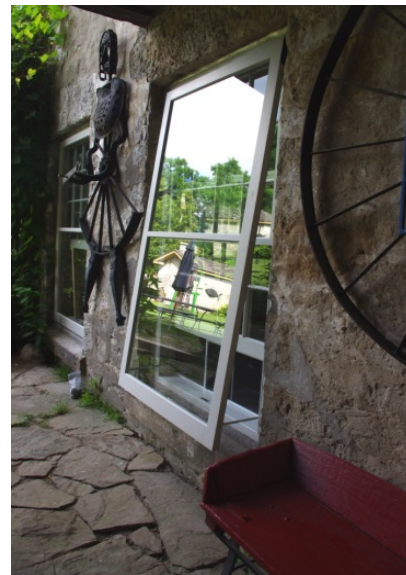
- Storm Windows –Operable awning style storm windows will allow for ventilation and if the storms are permanently fixed and non-operable they should be

ventilated at the top and bottom. General divisions may match those of the existing sashes or storm windows may be constructed in a 1/1 format in order to not visually compete with the historic sash they are protecting

The Trust does not recommend the replacement of existing windows as a means of increasing thermal efficiency. Historic windows that are in a good state of repair and properly sealed will minimize air infiltration. When storm windows are added to a historic window assembly they will perform just as well, if not better, than a newly manufactured double-glazed unit.

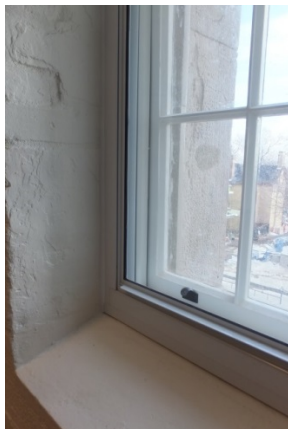
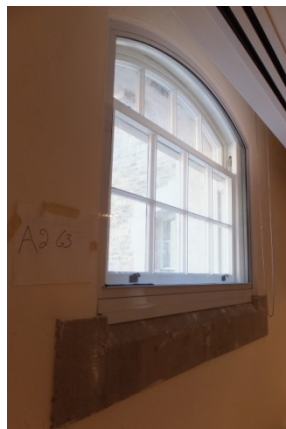
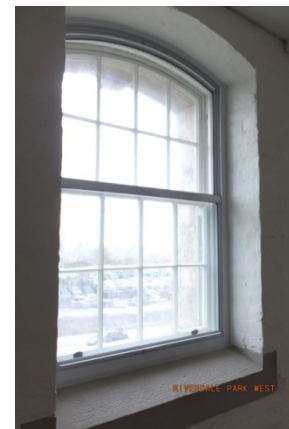
- Inter-changeable Storms and Insect Screens – wood framed storms and screens swapped out on a seasonal basis are the tradition pattern. If this is not practical, a permanent, fixed exterior frame with glass or insect screen panels top and bottom interchangeable from the interior is a practical alternative
- Interior glazing – Another option would be to add a removeable, “interior” storm. This would be secondary glazing on the inside of the building. Condensation that builds between the glazing layers must be vented to the exterior. The interior glazing should form a tight seal around the opening and the air space should vent to the exterior. This means that your primary glazing (interior) needs to be airtight while your secondary glazing (existing window) needs to allow moisture to travel to the exterior to prevent the build-up of condensation in the air space.
