HERITAGE RESEARCH REPORT

THE WILMOT BRUMWELL HOUSE

10391 Woodbine Avenue

Lot 23, Concession 4, Markham

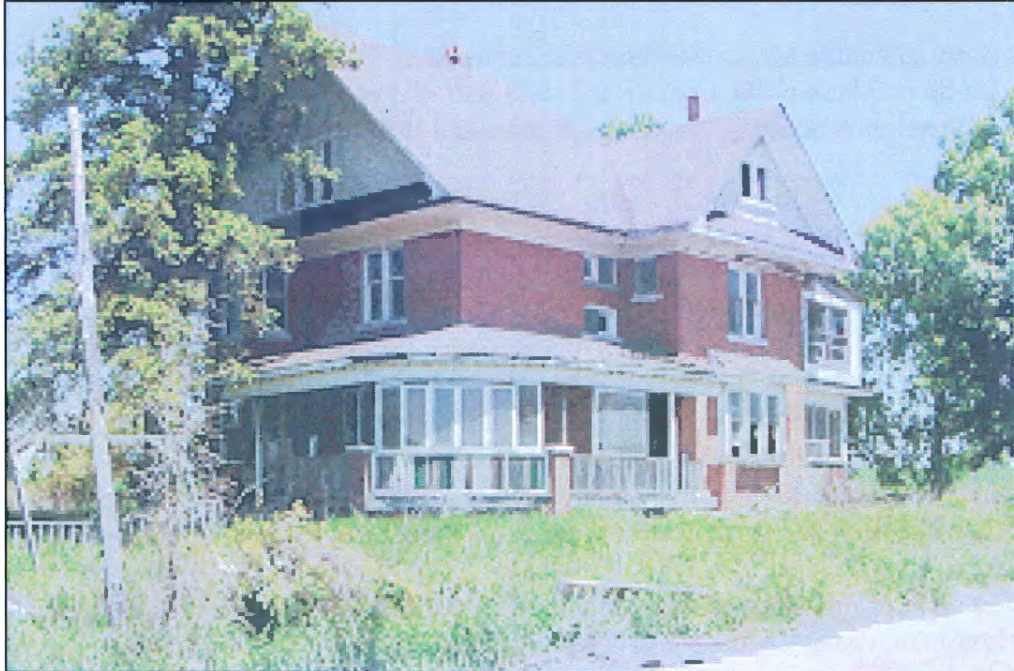
Although left neglected and vacant for the last few years, the Brumwell house retains much of its original form and architectural ornament both internal and external. The house was apparently very sturdily built and has stood the test of time well despite being abandoned to the elements.

The front elevation of the house is dominated by the substantial third storey gable. Finished in decorative shingles, this feature shows strong influence of the Queen Anne period.

On the left of the front façade is a two-storey bay window. Some excavation has taken place in recent years around the bay exposing the substantial fieldstone foundation. The presence of a stone foundation on the house and the presence of original Queen Anne detailing provide strong indication that the house is an early example of the style and was built in the first decade of the 20th Century.

In the upper right of the front façade are paired 1/1 windows. Below these windows can be seen the substantial curved veranda, which was originally held up with wooden Tuscan columns on brick piers. The Tuscan columns have been removed from the house over the past two years presumably by salvagers. At some point in the late 20th Century, the veranda was enclosed. The veranda features 1" x 2" rectangular pickets running around the south side of the veranda. The upper part of the veranda features decorative dentil moulding.

The south elevation features a smaller, enclosed Queen Anne style gable, with decorative fish scale shingles, over a projecting wing punctuated by two small windows which have been removed. It is believed that these windows were irregularly paned detail windows, typical of the period such as 3/1. Below the third level gable are two paired wood, double hung windows with a 1/1 pane division. On the first floor the face of the wing features a slightly projecting box bay window with 3 1/1 windows enclosed within it.
